Timber frame construction | Exterior wall

Airtight sealing of racking boards with pro clima TESCON VANA

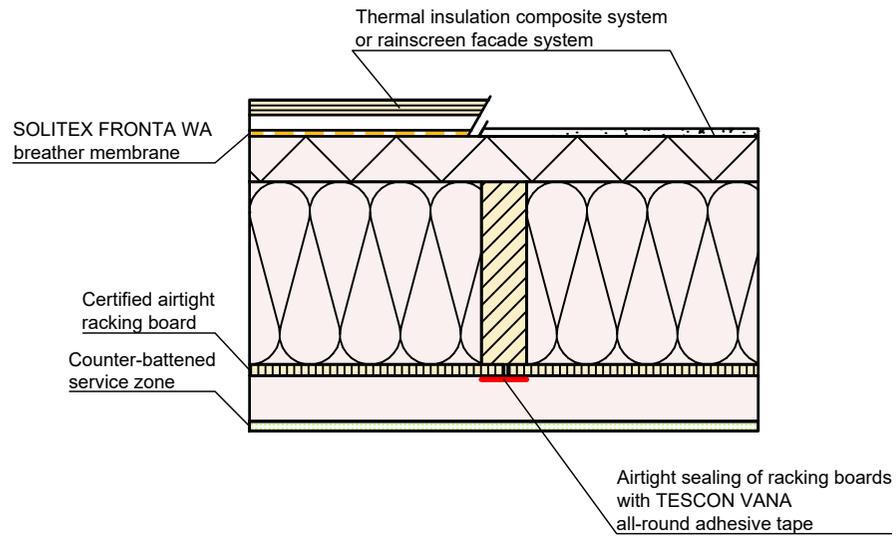
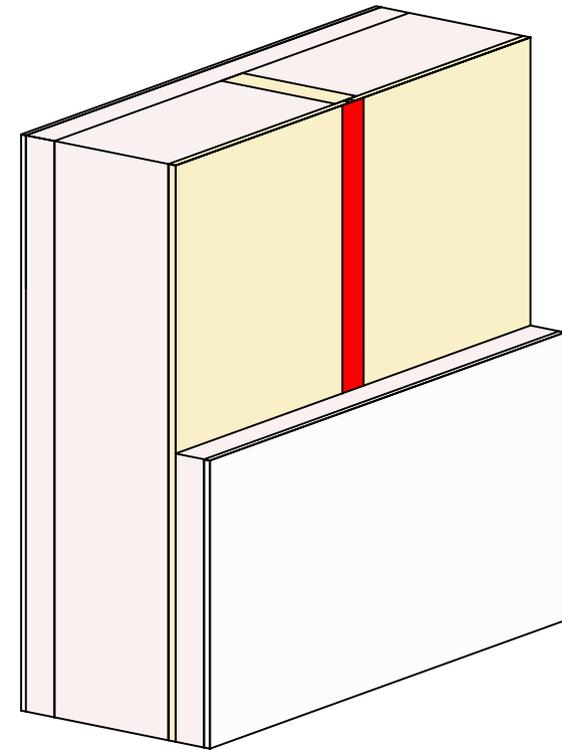
Typical structural situation to illustrate the airtightness and windtightness layers. When carrying out planning and performing installation on site, please observe the currently applicable technical regulations and the relevant pro clima recommendations for applications and installation. (German version: 09/21; international version 02/26)
